Bosnia and Herzegovina: Category A Road Project - Corridor Vc in RS

RIVER BOSNA BIODIVERSITY SCREENING

Draft Report

Job No.: ZWJ103
Client: EBRD
Date: 15 June 17

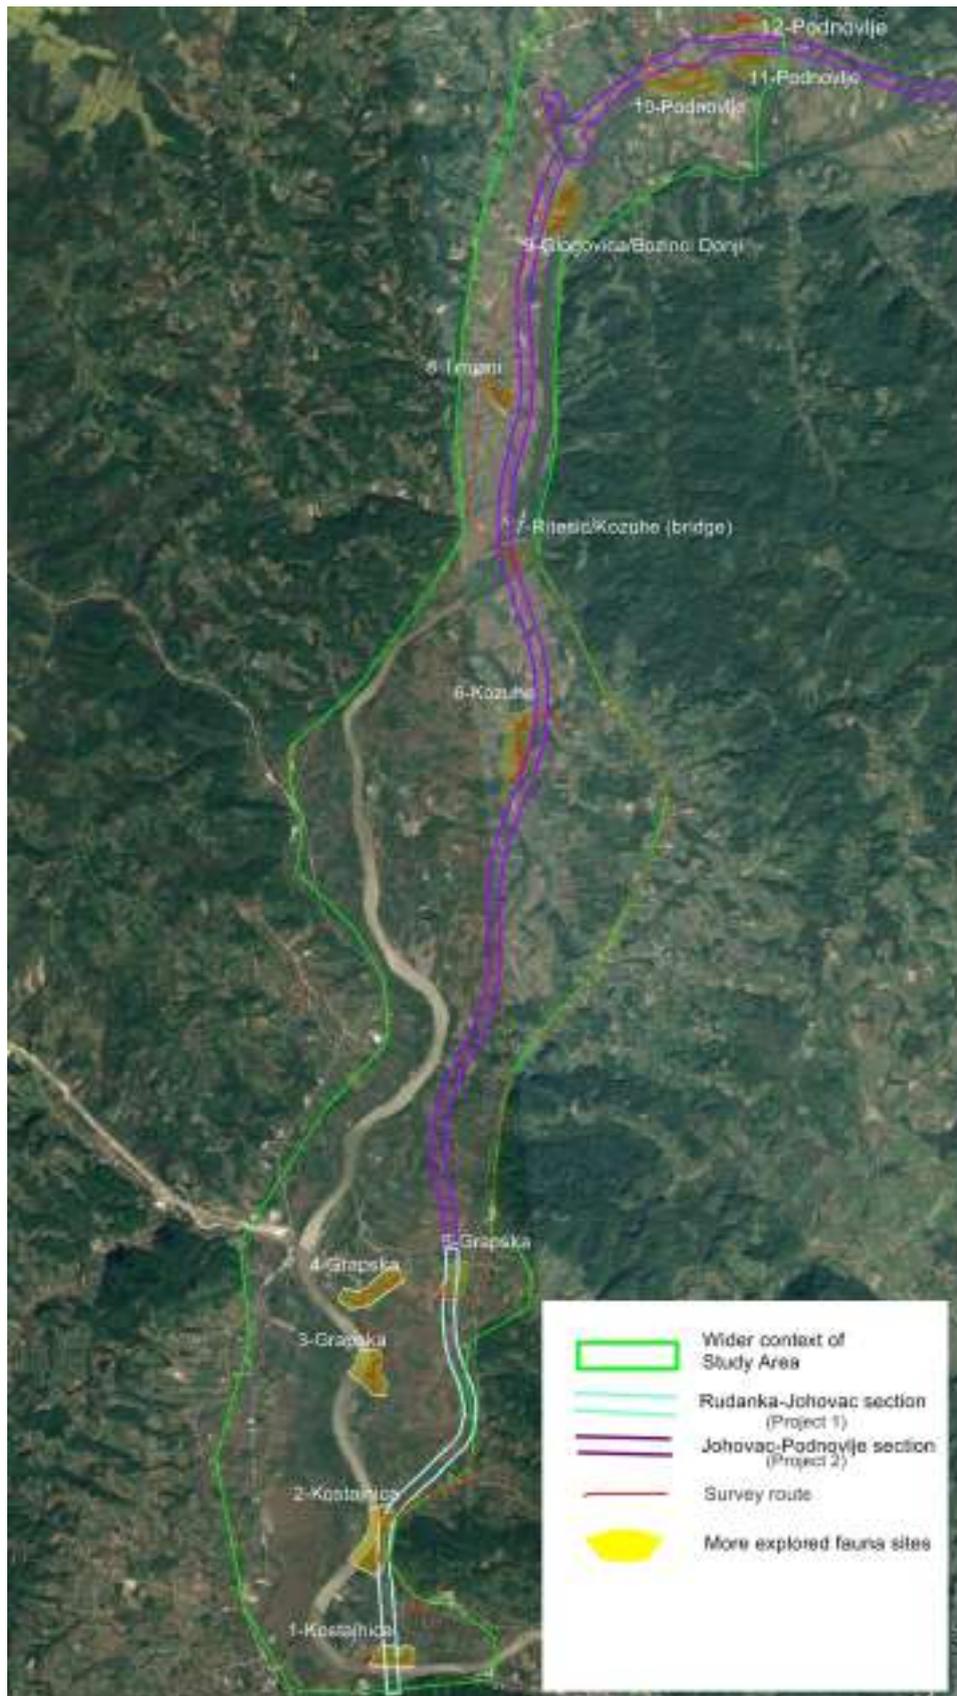
Map 1. Survey Extent and Areas of Focus

During the survey, areas considered to support priority biodiversity features according to the PR6 definition were identified and mapped, as well as all other areas considered to be of conservation interest. GPS locations of features of interest were marked, and are listed in Annex 1.

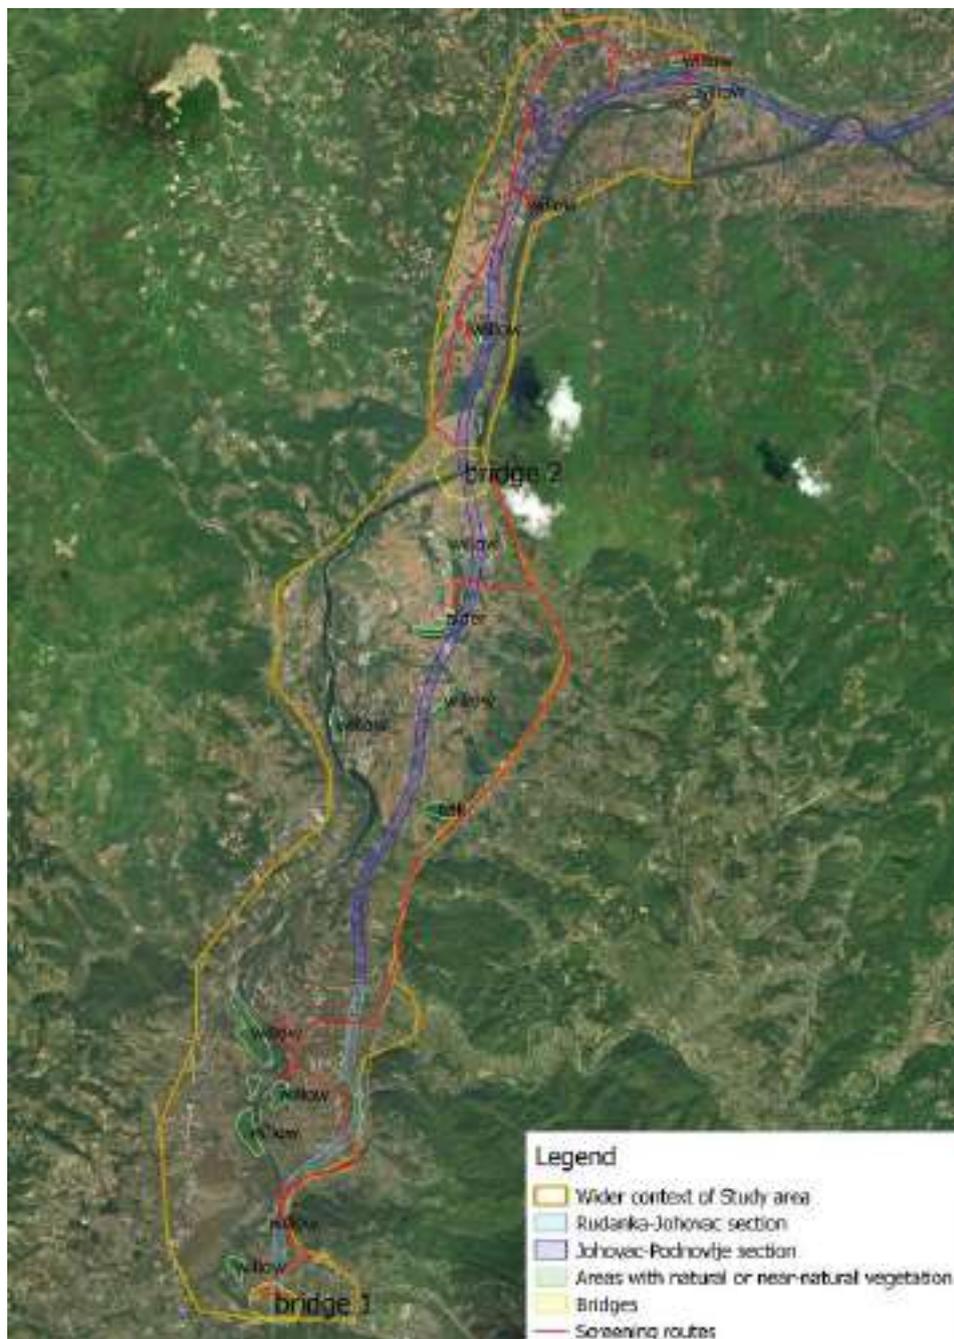
Map 2. Overview of the Study Area

The Study Area is situated within the wider context of the River Bosna and its associated floodplain. It is predominantly used for farming, primarily arable crops but there are also areas that have been significantly affected by gravel extraction activities. Some small areas of natural vegetation remain in the Study Area as isolated/fragmented patches. These are mainly structurally and floristically degraded riparian willow-poplar or alder woods, but provide important habitat islands in an otherwise modified landscape. The key vegetation features of the Study Area are marked on Map 2. These are described in subsequent sections. The red lines marked on Map 2 and labelled 'screening routes' indicate the main traverses done by the survey team.

Fifteen isolated patches of structurally and floristically degraded riparian willow-poplar or alder woods. were identified, as shown on Map 2. These represent priority biodiversity features, according to the definition of EBRD's PR6. Thirteen are predominantly willow, one is dominated by oak, and one by alder. This alder stand conforms to the habitat type listed in Annex 1 of the EU Habitats Directive – 'Alluvial forests with *Alnus glutinosa* and *Fraxinus excelsior*, 91E0*. These features are shown at a larger scale in the Maps in Annex 2.

Alder Woods: Alder woods are represented by one well developed stand in an old riverbed near the village of Kožuhe, as marked on Map 2 above, and Map 2.2 in Annex 2. See also Photo 1 below.

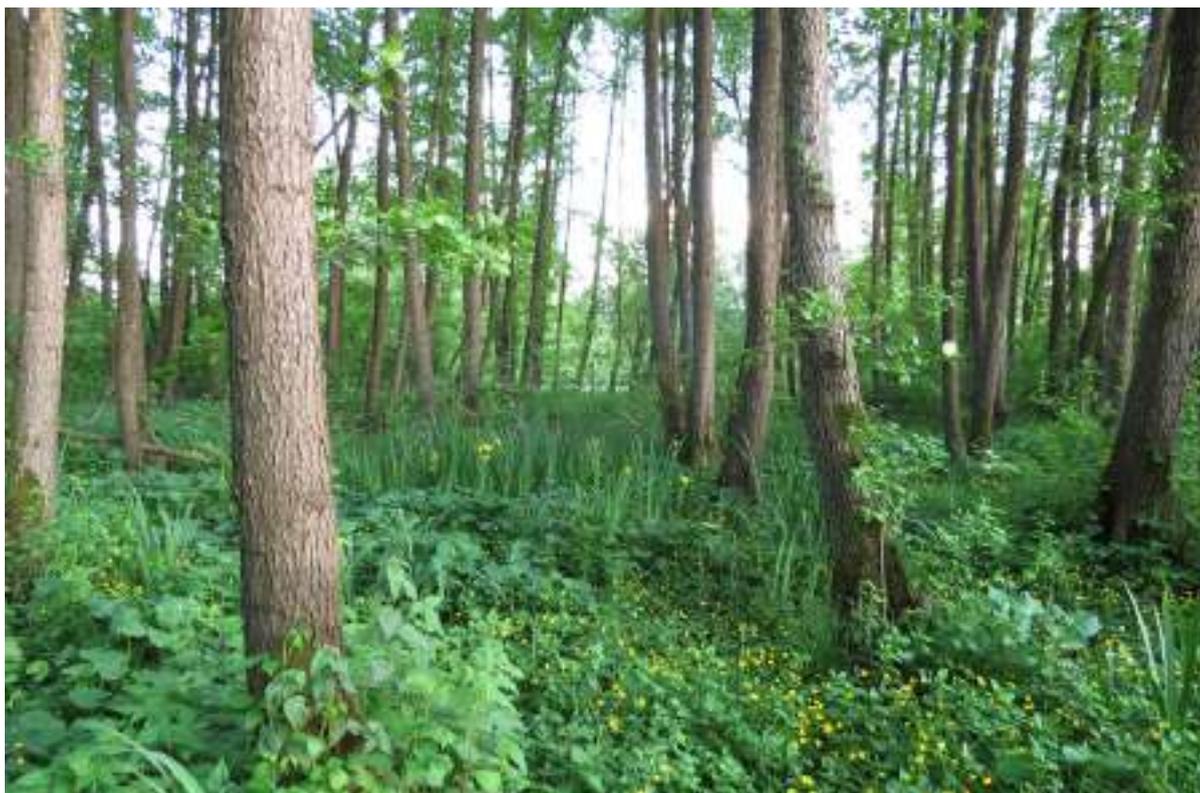
Photo 1. Alder Woods Near Kožuhe Village

The stand is representative for the habitat type, with very characteristic or typical species including: *Alnus glutinosa*, *Frangula alnus*, *Rubus caesius*, *Carex riparia*, *C. vesicaria*, *C. remota*, *C. strigosa*, *Iris pseudacorus*, *Caltha palustris*, *Ranunculus repens*, *Galium uliginosum*, *Circaea lutetiana*, *Peucedanum aegopodioides*, *Ficaria verna* etc. **Although the study area is not planned to be included in the Natura 2000 network (see Section 6 below), this habitat is listed on Annex I of Habitats Directive and is considered to represent priority biodiversity features as per EBRD PR6, thus steps should be taken to preserve the site.**

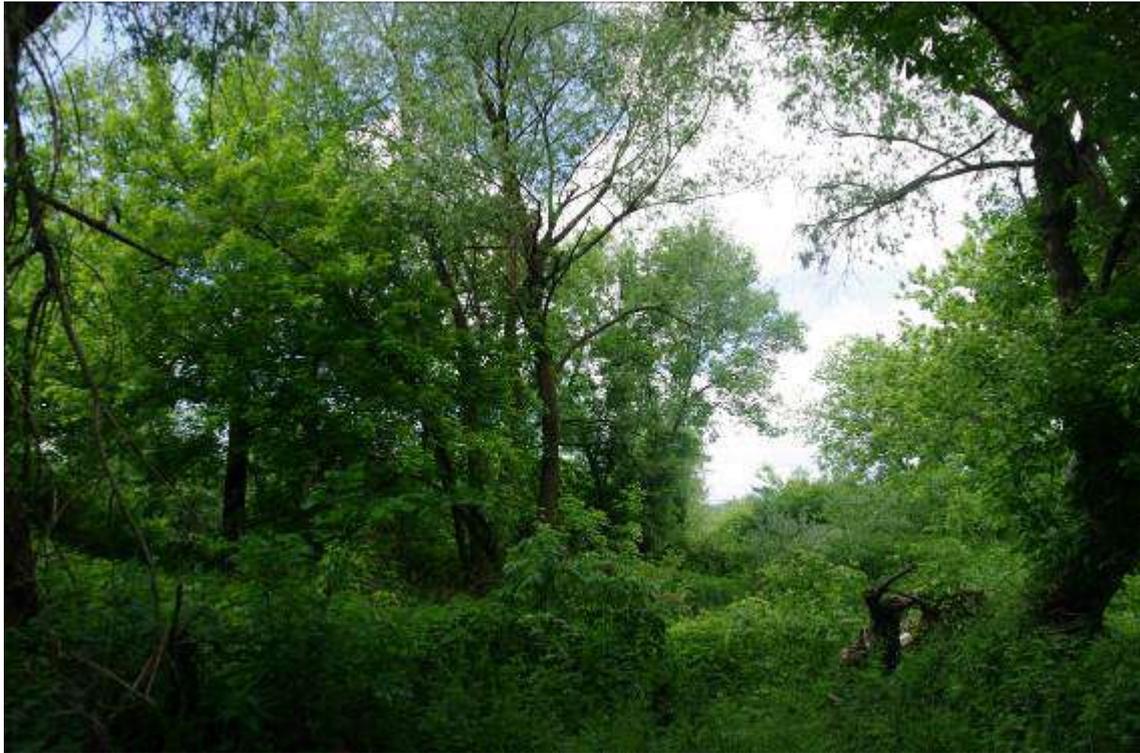
Photo 2. Degraded Willow Woods

Willow-Poplar Woods: Willow-poplar woods are represented by several small patches near the River Bosna, as shown in Map 2, and on Maps 2.1 – 2.3 in Annex 2. These are mainly very degraded by illegal logging, gravel extraction, invasive species and trash accumulation, see Photos 2 and 3 below, but are considered to constitute potential priority biodiversity features according to EBRD PR6.

These willow sites in the Study area are not recognized as priority biodiversity features in this area, since they are degraded and unrepresentative of the habitat type. In addition, these sites are mainly far from the motorway corridor, and lie between the river and motorway, so are not likely to be directly impacted by the Project.

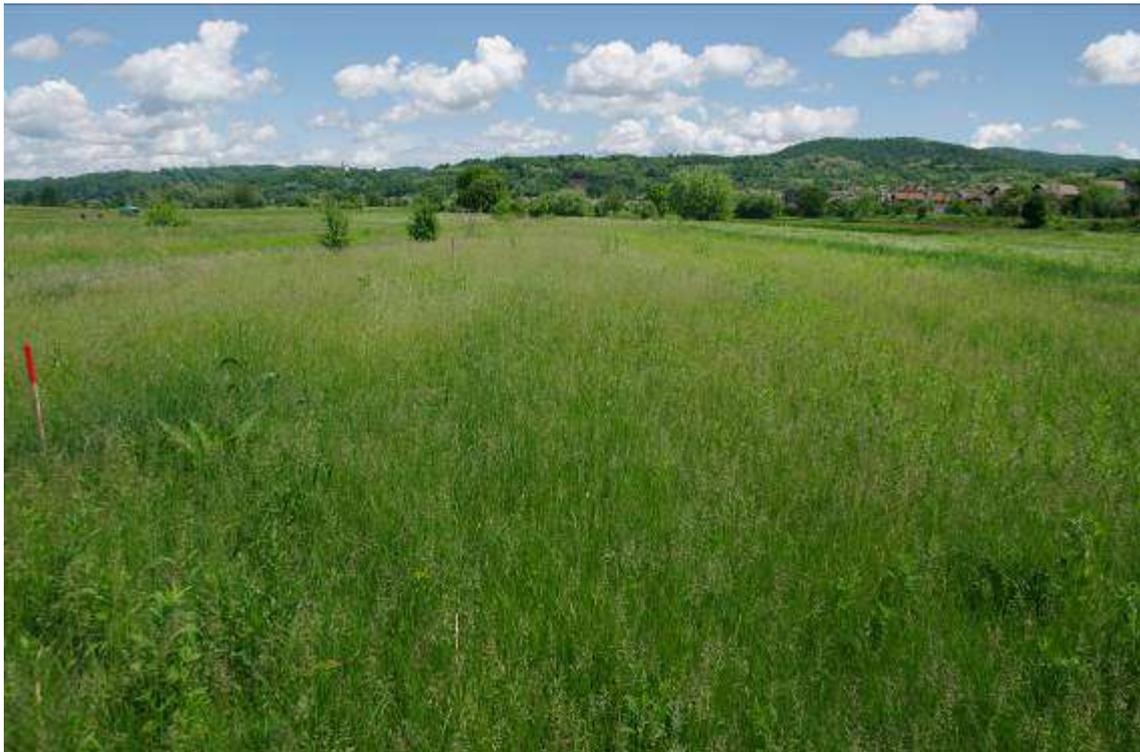
Photo 4. Early Successional Stages Towards Mesophilous Grassland on Abandoned Cropland

One other example of “near natural” vegetation in the Study area is a number of small patches or narrow strips of early successional stages of mesophilous grassland on abandoned cropland, see Photo 4. Apart from its nearly-natural nature, this has no conservation significance.

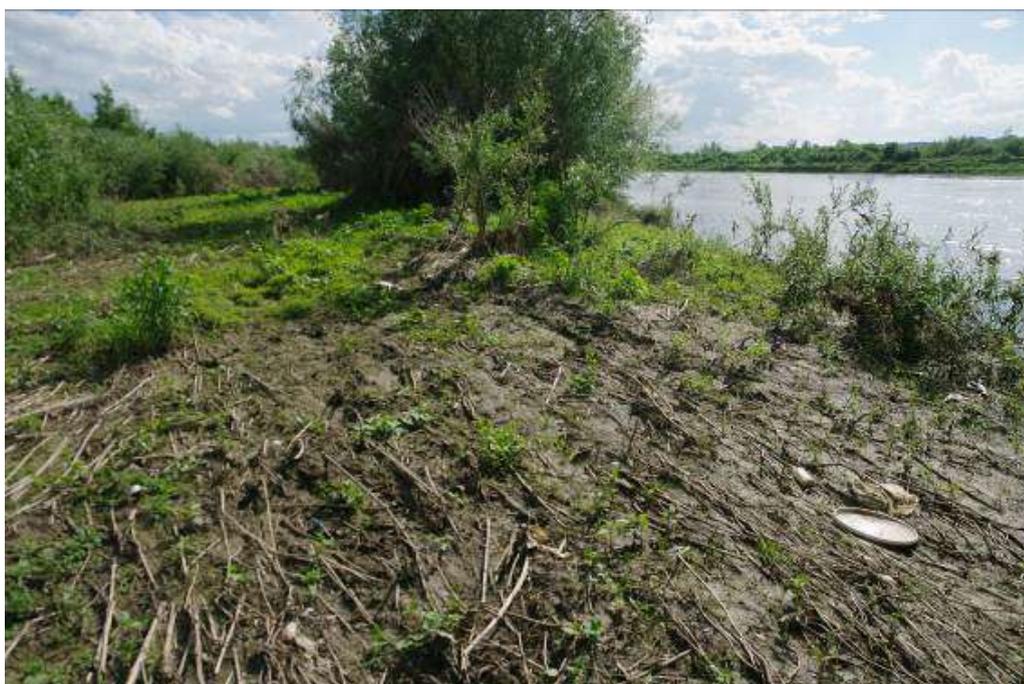
Photo 5. River Bank. Possible site of Annex 1 Habitat Type 3270 (Muddy river banks with annual pioneer nitrophilous vegetation of the *Chenopodium rubri* p.p. and the *Bidention* p.p. alliances)

There are also very likely to be some smaller areas of a riverine habitat type characterised as ‘Muddy river banks with annual pioneer nitrophilous vegetation of the *Chenopodium rubri* p.p. and the *Bidention* p.p. alliances’. This is also listed in the EU Habitats Directive (code: **3270**). (*Annex 3, Photo 1*). Photo 5 below shows a likely site of this habitat, although as this kind of vegetation only develops later in the year, its presence could not be confirmed during the survey, and the species checklist could not be made. This would also represent a priority biodiversity feature according to EBRD PR6.

Although not confirmed by the surveys, parts of the river banks may contain the habitat type listed in the Habitats Directive as 3270 'Muddy river banks with annual pioneer nitrophilous vegetation of the *Chenopodium rubri* p.p. and the *Bidention* p.p. alliances'. Since this is listed as an Annex I habitat type, it would be considered to be a Priority Biodiversity Feature. As a precaution, damage to the river banks must therefore be avoided where possible and minimised where necessary. Some temporary damage to the river banks will be unavoidable at the two short sections of river bank where the bridge construction will occur. Although this habitat type is not yet confirmed at these locations, steps should be taken to confine the construction works to the area where work is strictly necessary, and to ensure that a full reinstatement of the river banks is performed once the works are complete. In addition, steps should be taken to ensure that no other section of the river banks are damaged, or even accessed by the contractor during the works.

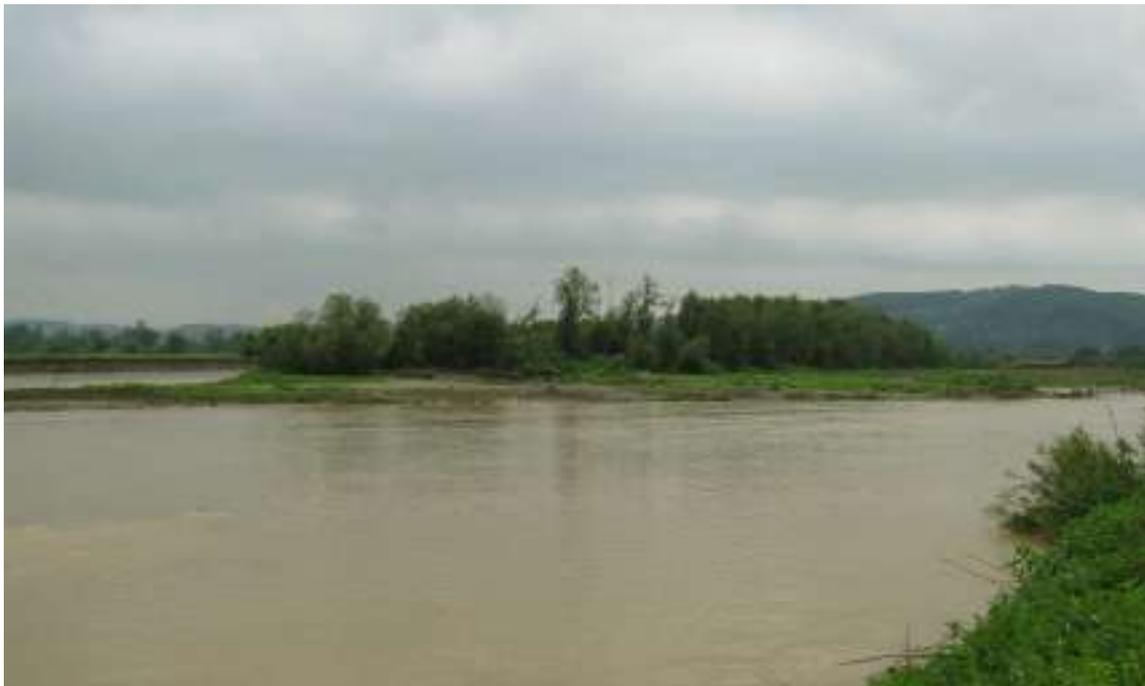
Photo 6. Island Within the River Channel

Birds: The list of birds recorded in the area is found in Annex 7. From the data collected on the bird species present along the planned route of motorway, it is clear that there are no sites that contain significant populations of protected species nor are there any individual nesting places that could be particularly endangered by the Motorway construction. Habitats which could have potential importance for birds include the riverbanks, river branches and the backwaters, however, none of these are within the area where vegetation will be disturbed by Motorway construction. Photo 6 shows an island within the river channel, which could be a suitable habitat for birds.

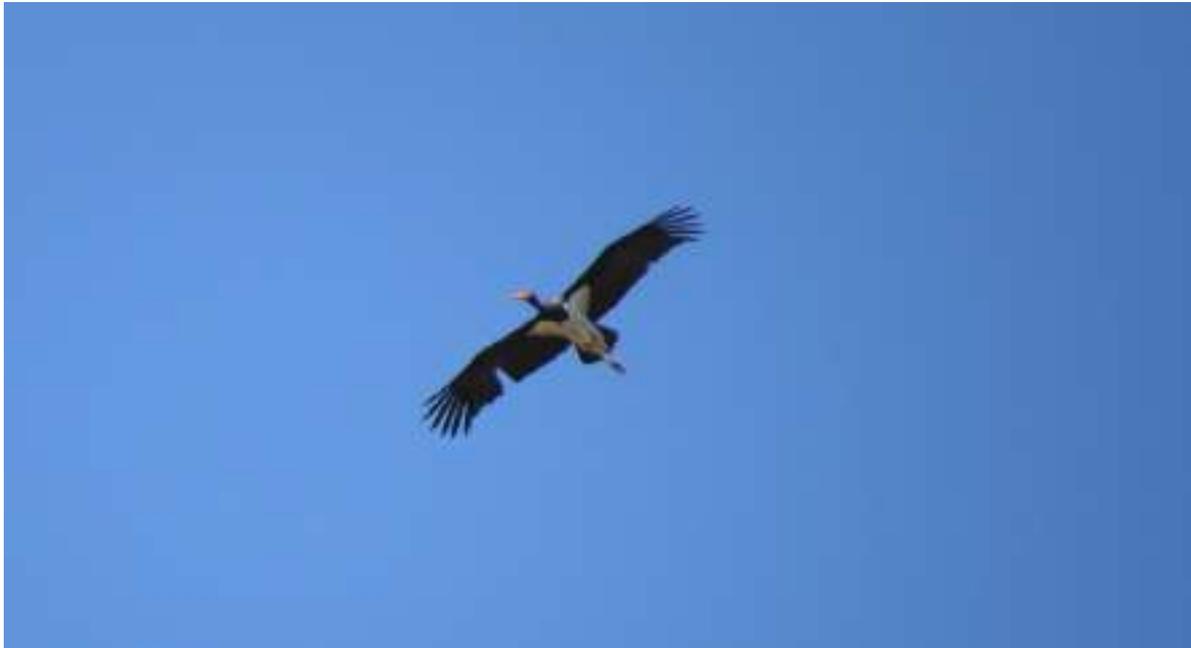
Photo 7. Black Stork Sighted in Study Area

The non-nesting species of conservation interest recorded in the area include: *Ciconia nigra*, *Ardea alba*, *Egretta garzetta*, *Nycticorax nycticorax*, *Sterna hirundo*, *Dryocopus martius*. Photo 7 shows the Black Stork (*Ciconia nigra*), one of the protected bird species that visits the River Bosna during

its daily searches for food. Although spotted in the overall Study Area, these species are just as likely to be found outside of the Project corridor, as within it. These birds often fly over the Project area or visit sites within it during the daily search for food.

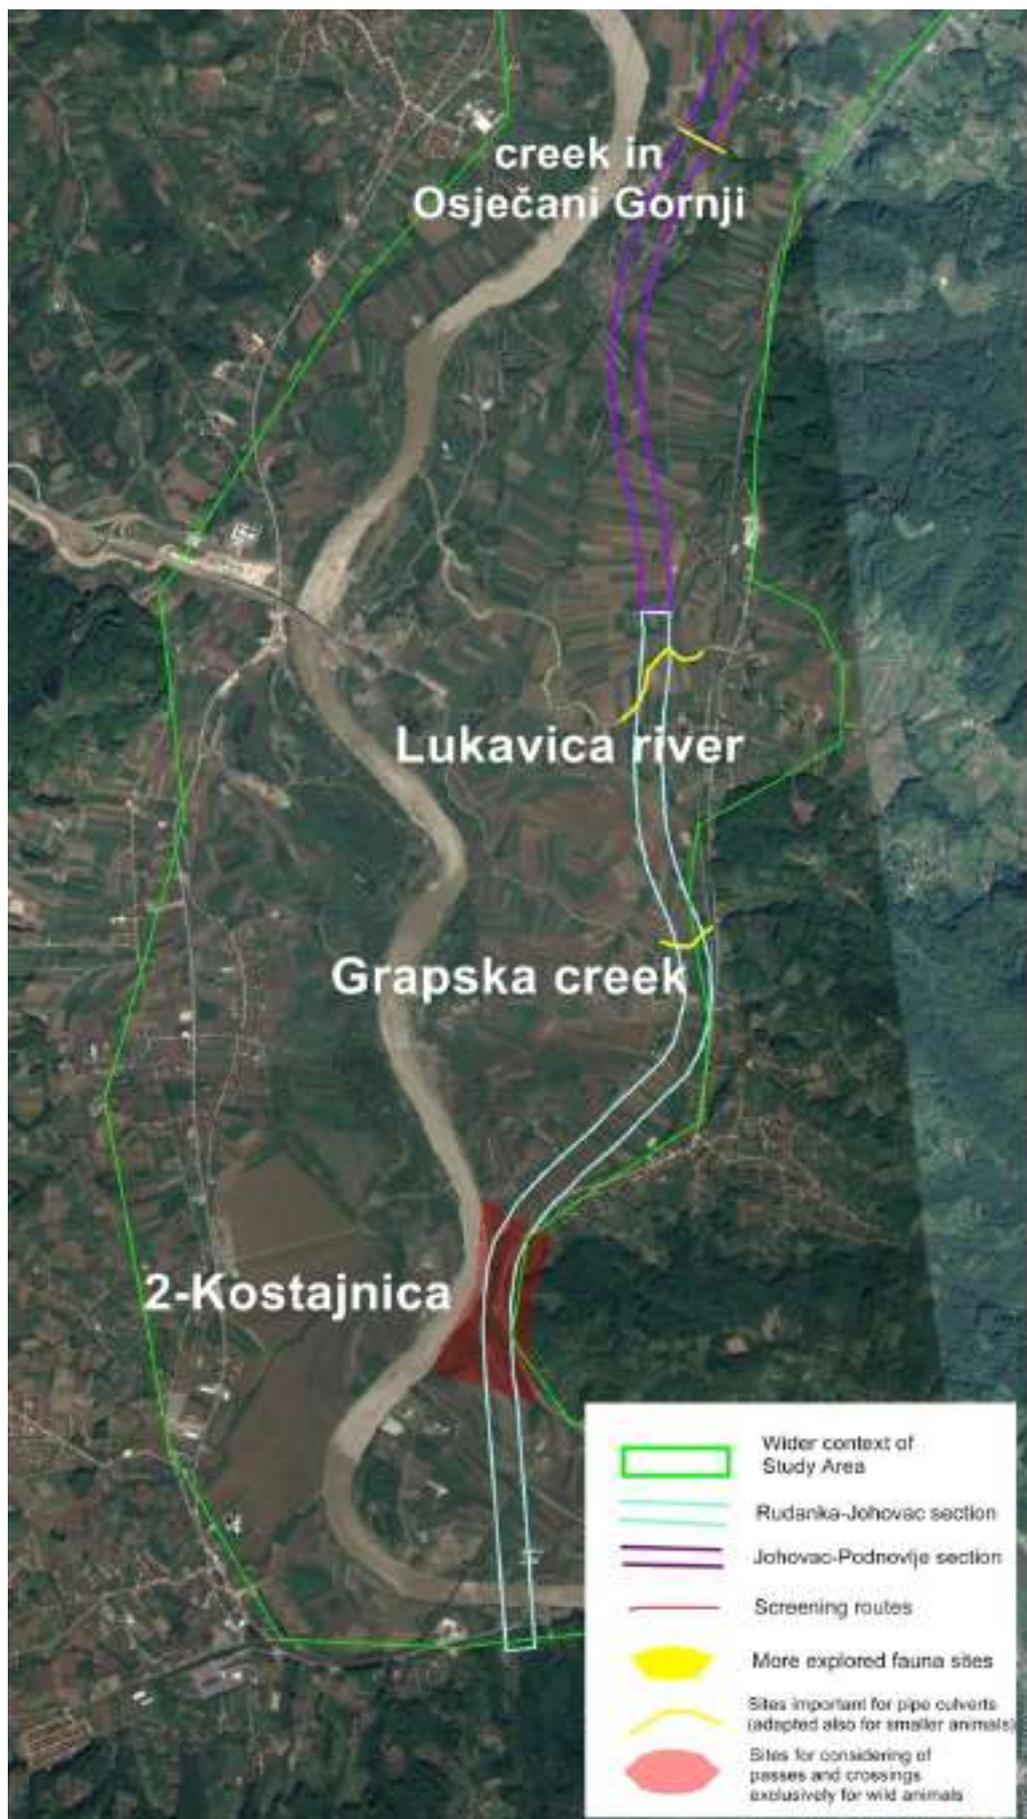
Map 3. Wildlife Crossing Zones at Site 2. Kostajnica

Several species of mammals noted in the Study Area are considered game for hunting - *Lepus europaeus*, *Canis vulpes*, *Canis aureus*, *Martes foina*, *Meles meles*, *Capreolus capreolus*. Based on information from the survey and confirmation from local hunters, these are particularly represented at two points:

The locations of these can be seen marked on Maps 3 and 4 shown earlier, and on Map 5 below. Species such as *Romanogobio uranoscopus* (listed in Annex II of the Habitats Directive), *Romanogobio kessleri*, *Barbus balcanicus* (listed in Annex V of the Habitats Directive) and *Cottus gobio* (listed in Annex II of the Habitats Directive) were recorded downstream in the municipality of Modriča and it is possible that these could also use certain tributaries of Bosna River and their upper reaches. The presence of these species could be a potential reason for interest in the Bosna River as a system which needs a degree of protection, as the Habitats Directive requires steps to be taken to manage the core habitats of these species. However, provided that adequately sized culverts are provided in the places where the Motorway intersects these streams/tributaries and other watercourses to maintain the flow and connectivity between these streams and the River, and that the natural state of sediments is maintained in all these tributaries, negative impacts that could affect the natural movement of fish between the mentioned watercourses and Bosna river is considered to be negligible.

These tributaries have been identified on Map 3, 4 and 5, and are known to the Project designers. It is understood that the design will incorporate culverts as necessary at these streams, to allow continued drainage to the river. These culverts will also allow passage of animals, so the overall residual effect should be minor. However, flow and animal passage through these must also be maintained during construction and the specific requirements of otters must be considered to ensure that designs allow their safe passage during all conditions, including when rivers are in flood. For otter, installation of ledges within the culverts should be considered, for example. These measures are necessary to ensure there is no net loss of biodiversity as a result of the Project, which is a requirement that is applied to priority biodiversity features.

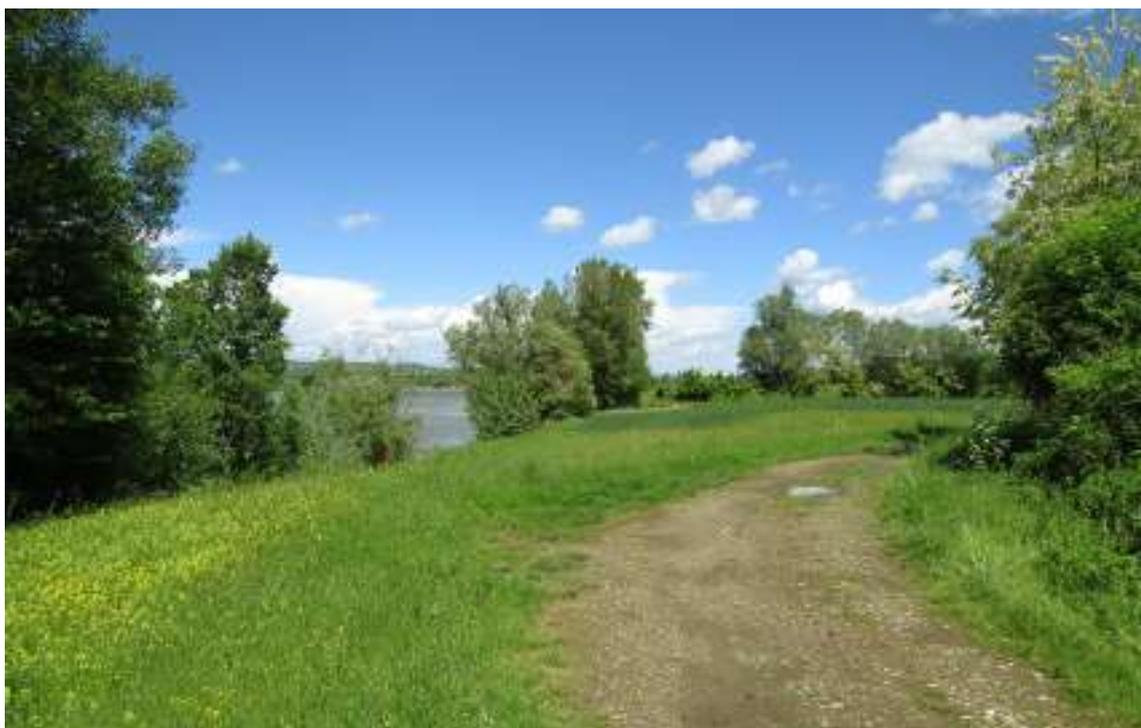
Photo 8. Site 2, Potential Animal Crossing Zone at Kostajnica

These locations are marked in red in Maps 3 and 4 below, and are illustrated in Photos 8 and 9.
